METEOROID/SPACE DEBRIS IMPACTS ON MSFC LDEF EXPERIMENTS

Miria Finckenor

NASA/Marshall Space Flight Center (NSFC)

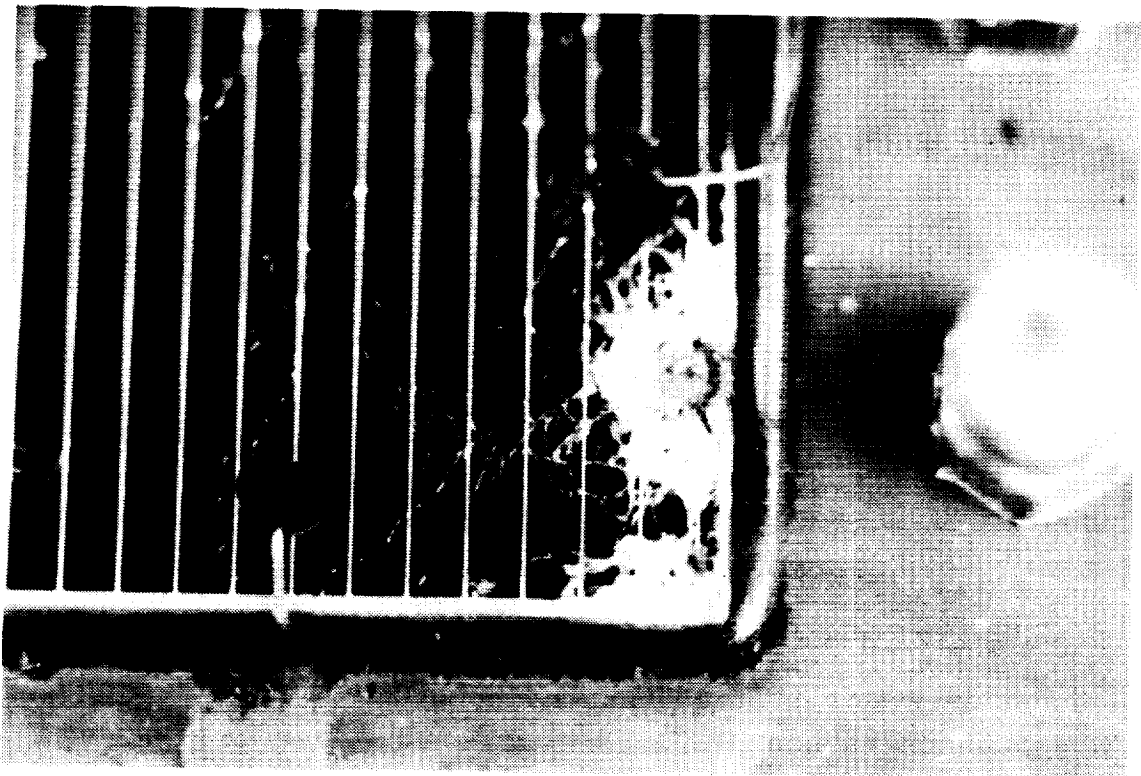
Generally, few material properties have been determined that would be directly affected by meteoroid and debris impacts. Solar cells with debris impacts and cracked cover slips {Figure 2} provide maximum power output similar to those not impacted. Interconnect tabs were penetrated, but a negligible amount of material was removed. Impacts and penetrations did not interfere with the mechanical peel tests of thermal control tape on fiberglass/epoxy substrates. However, impacts have interfered with optical property measurements. For example, the 1" dia. Tiodize K-17 sample from Plate IV has a relatively small (0.55 mm) crater with a large (4.1 x 3.0 mm) spall zone. {Figure 3}

Figure 2. Solar cell, ~2 mm dia. impact crater, ~5 mm dia. fracture zone

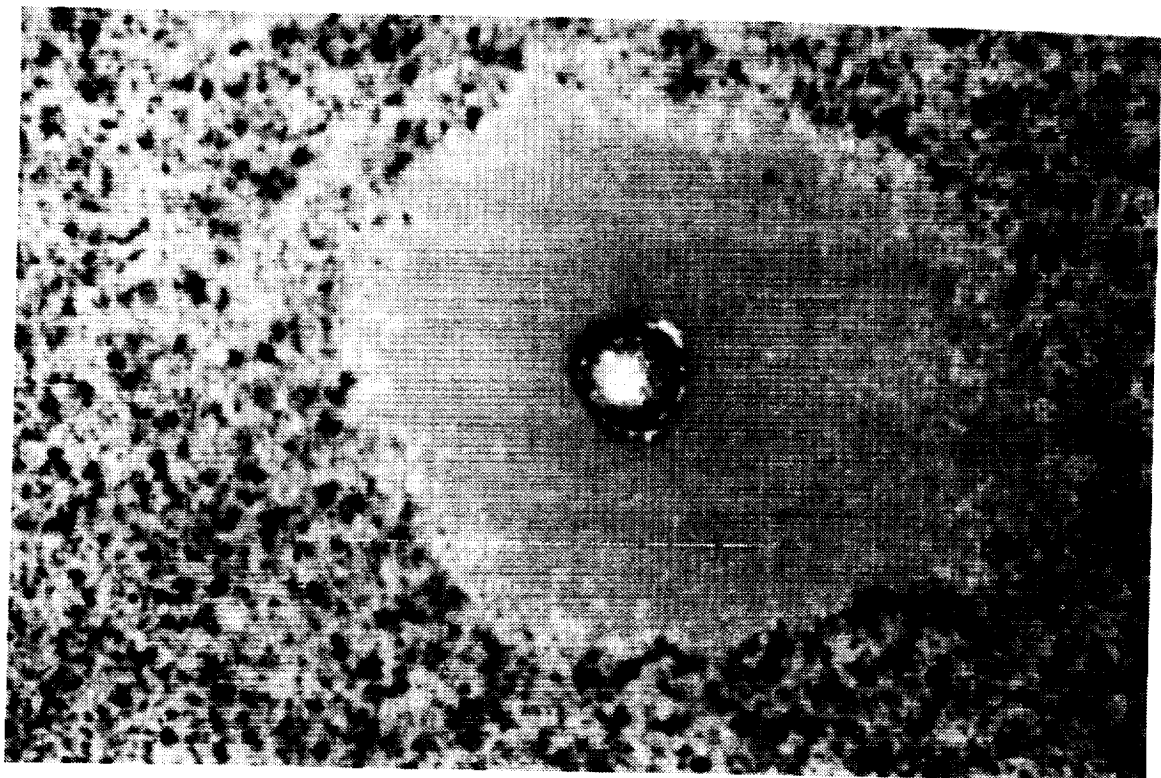
Figure 3. Tiodize K-17 on titanium, 0.55 mm dia. impact crater, 4.1 x 3.0 mm spall zone

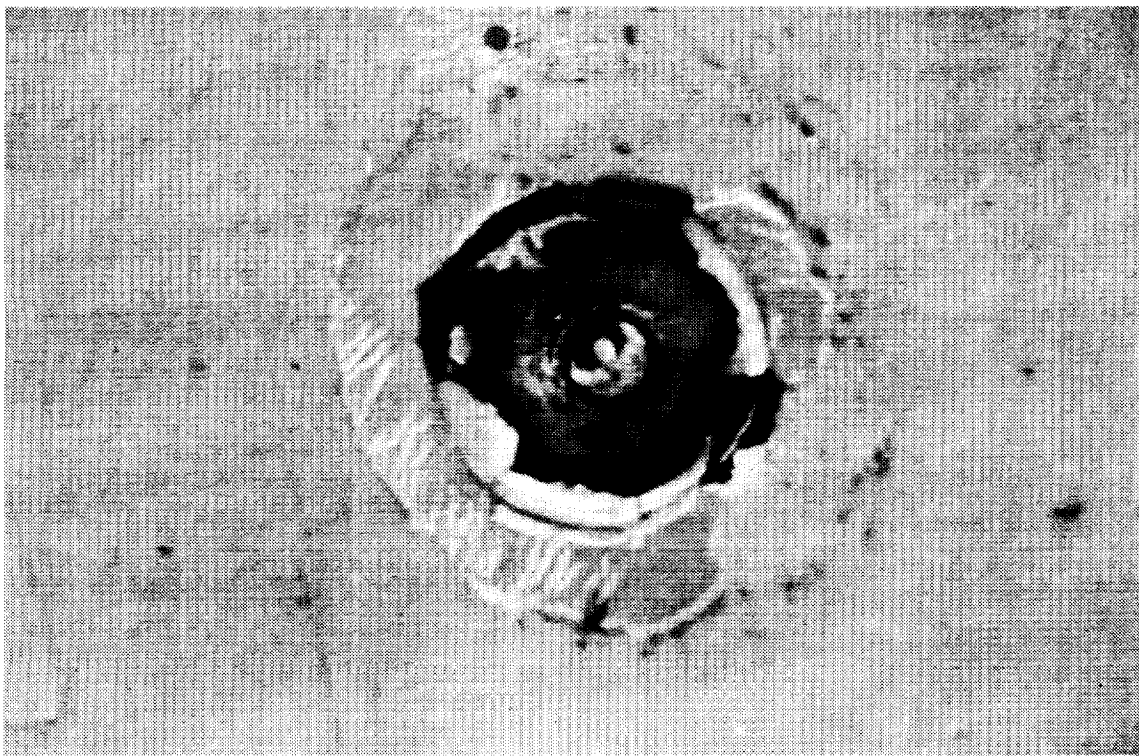
The heat pipes were covered with 5 mil silver/Teflon. Impacts into this material were typical, with the darkened rings around the impact area and delamination of Teflon. {Figure 5} There were also craters through the silver/Teflon into the aluminum of the heat pipes. The diameters of these secondary craters have been noted in the photographic record as well.

Figure 5. 5 mil Silver/Teflon on aluminum, 1.2 mm dia. crater, ~4 mm dia. dark spall ring
